Image Corrections in SWIR

Dr Louis Keal – Version A0, 10th March 2021

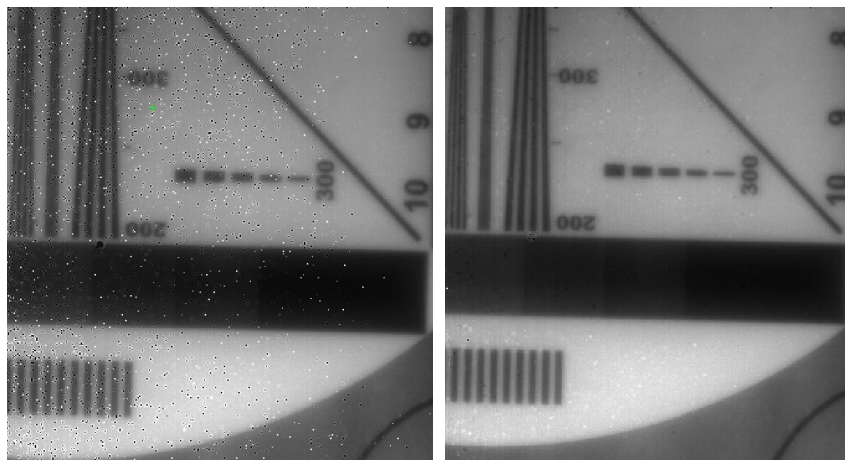
Figure 4: Before & after pixel, cluster & star correction

As a result, the location of clusters or blemishes on the sensor of the NIRvana camera range is also mapped by our engineers, and included in the defect map that LightField uses for correction. This allows a more accurate correction to be performed.
